**EXPLANATION OF SIGNIFICANT DIFFERENCES FOR  
SECTION 36 BALANCE OF AREAS SOIL REMEDIATION PROJECT  
ROCKY MOUNTAIN ARSENAL FEDERAL FACILITY SITE**

Prepared by:  
Tetra Tech EC, Inc.

Prepared for:  
Rocky Mountain Arsenal Committee  
Department of the Army  
Shell Oil Company  
U.S. Fish and Wildlife Service  
U.S. Environmental Protection Agency  
Colorado Department of Public Health and Environment

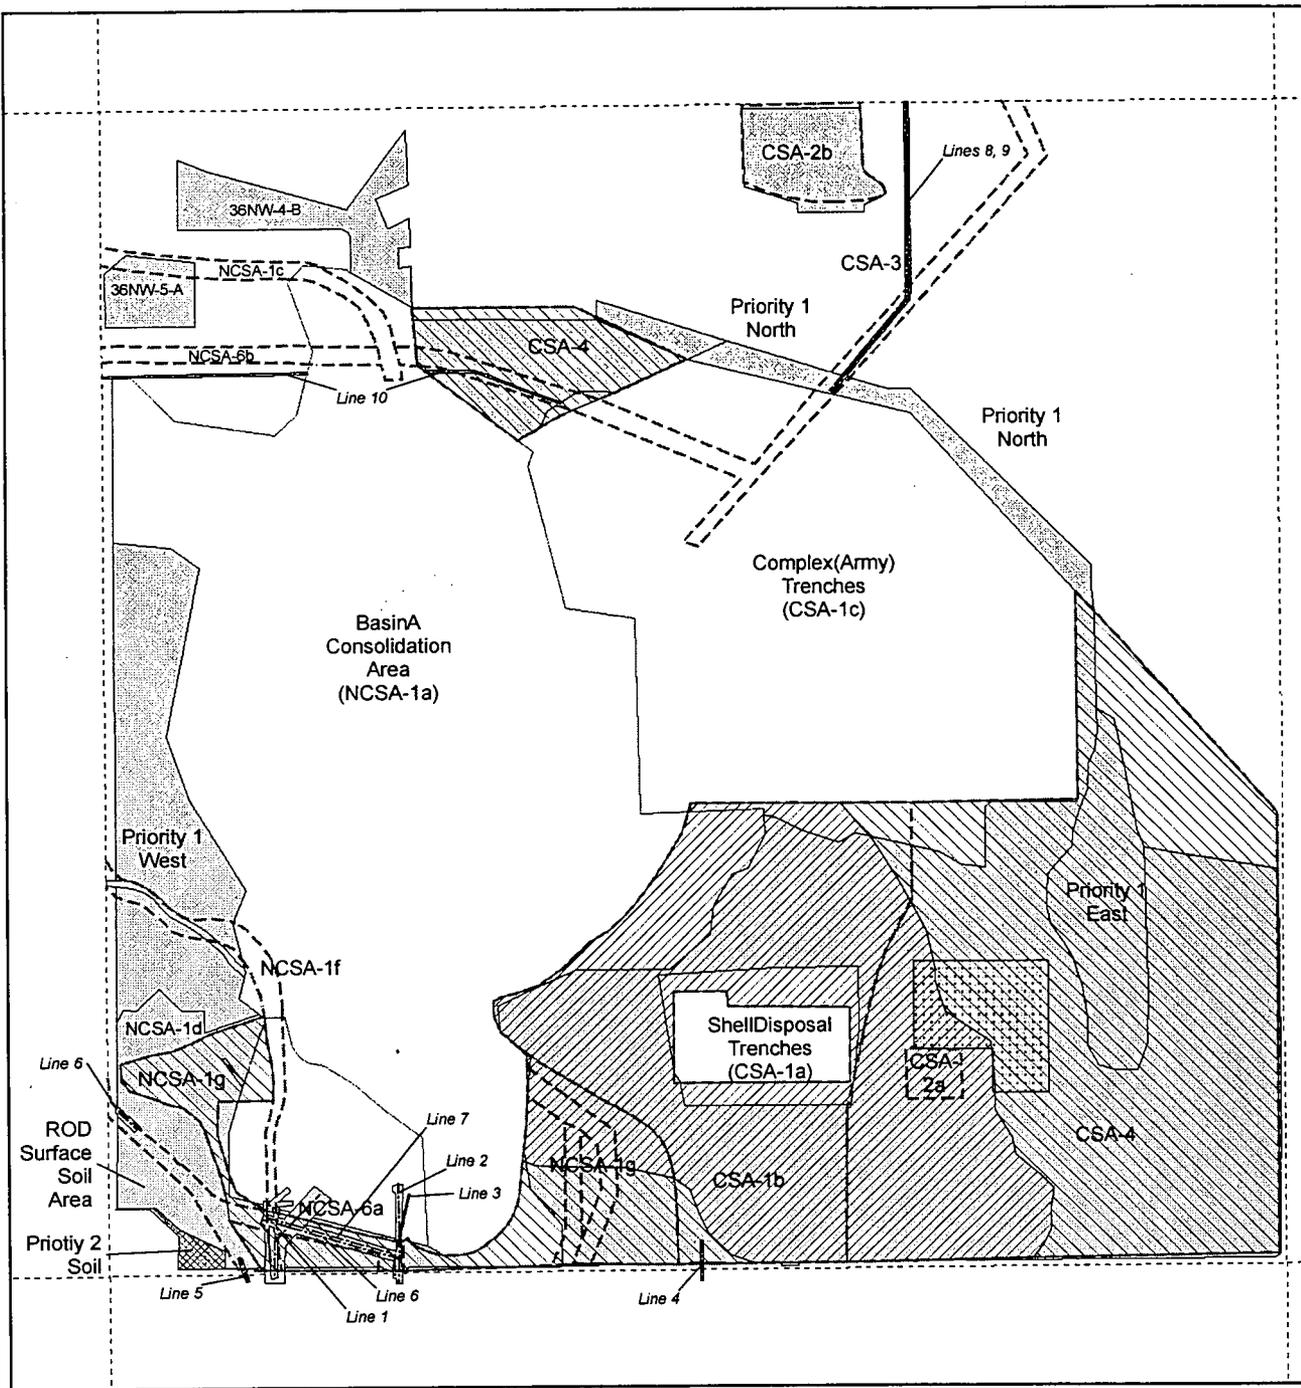
**Figure 1.0-2**

### Section 36 Balance of Areas Project Areas

are discussed in detail in the ESD completed during design (FWENC 2003e). The original ROD boundaries and modified design boundaries are shown on Figure 1.0-2.

Remediation within the ESS area, shown on Figure 1.0-2, consisted of a sweep using both an electromagnetic detector (all metals) and a magnetometer (ferrous metal). This clearance method is commonly referred to as "mag and dig." All surface and subsurface anomalies identified during the sweep were recovered and characterized (FWENC 2003a). After the mag and dig clearance the ESS area was released for soil excavation along with the rest of the Section 36 BOA project area.

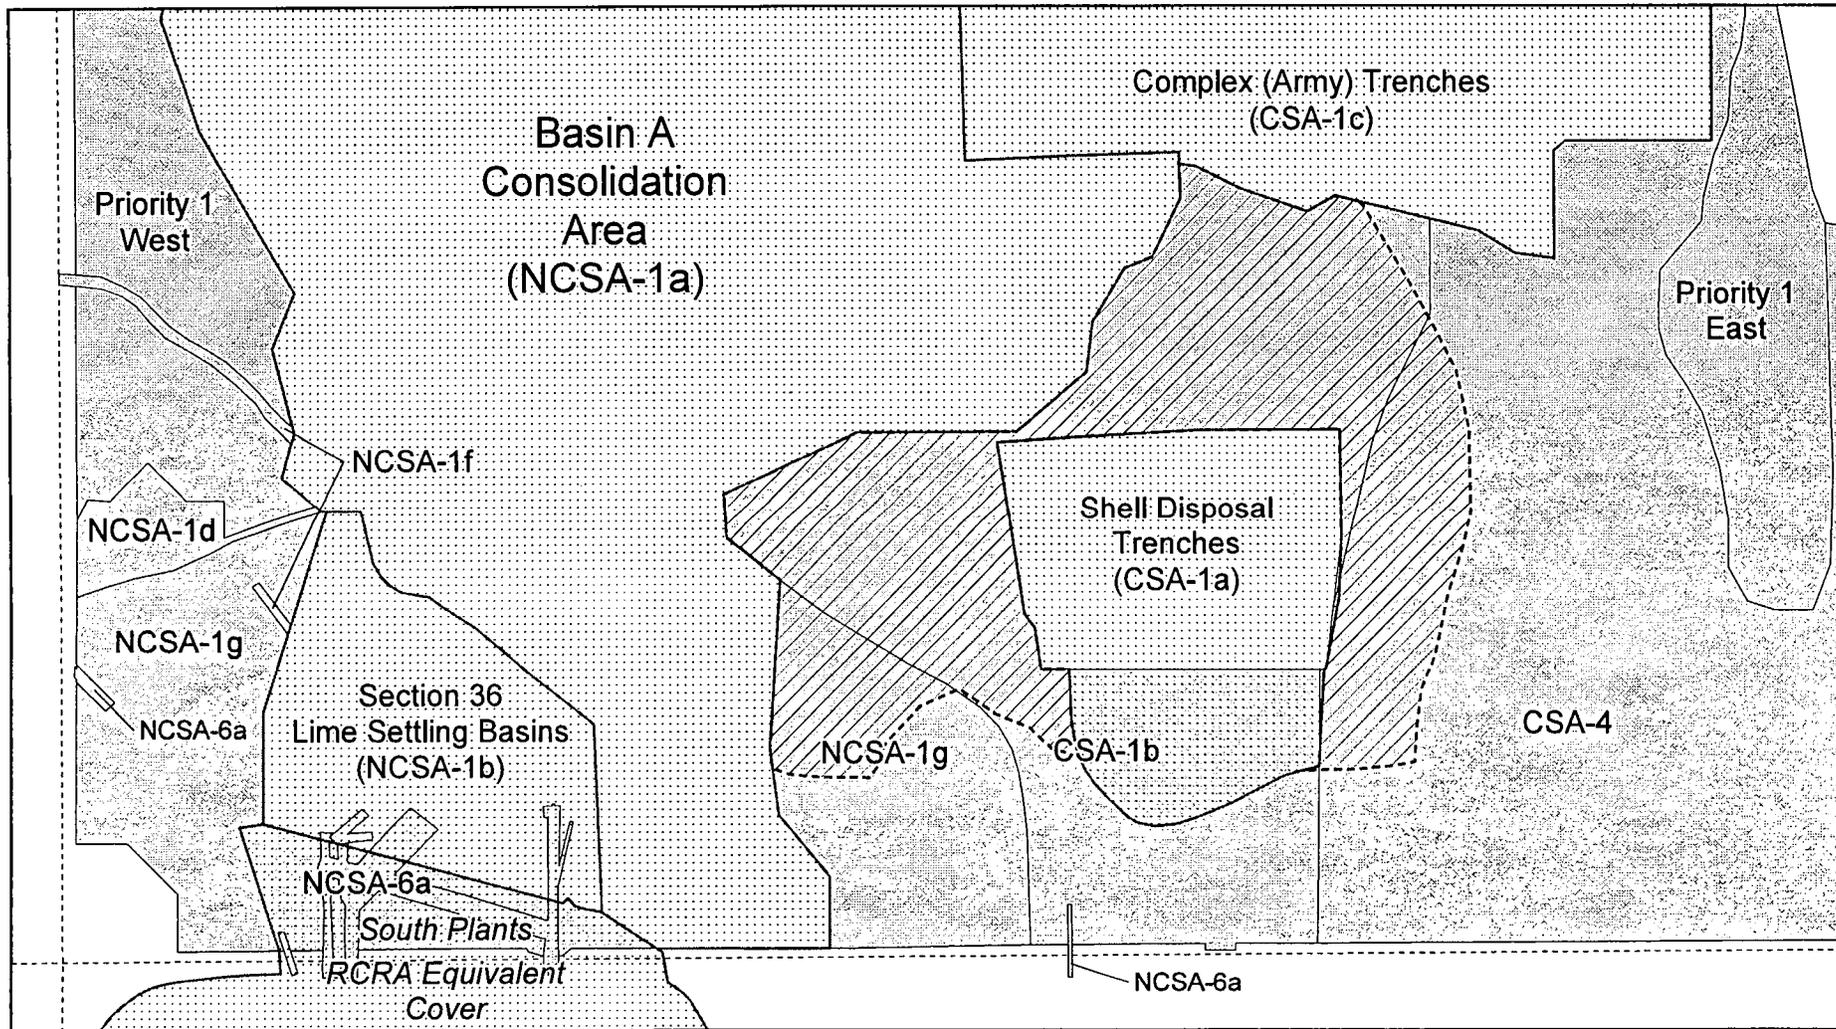
**Figure 3.1.1-1**

**ROCKY MOUNTAIN ARSENAL**  
 Section 36 Balance of Areas Project Boundary Changes

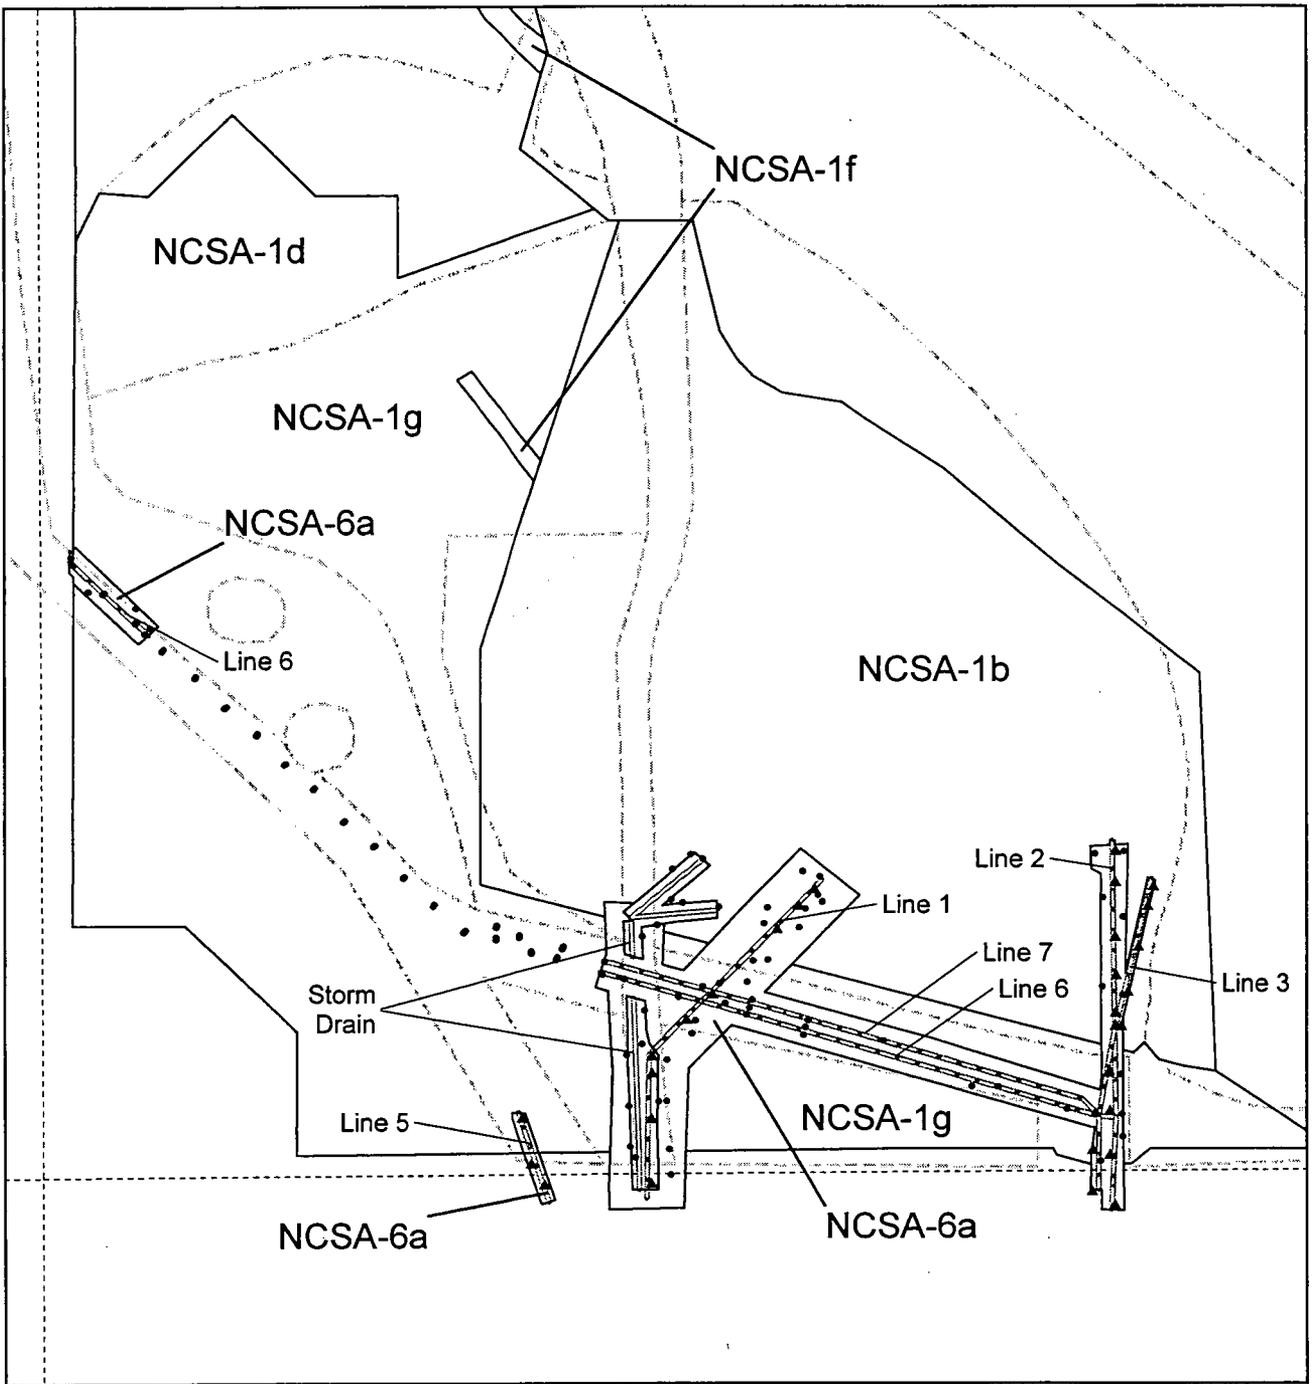
**Figure 3.2.1-1**

**Section 36 Balance of Areas  
South Plants Chemical Sewer Area**

Consistent with the ROD and design ESD, the Section 36 BOA design included excavation of South Plants chemical sewer Lines 1 through 5 and North Plants chemical sewer Lines 8 through 10. Following excavation of the design volume along the chemical sewer lines, additional sampling was completed in accordance with the FCS SAP to determine if HHE soil was remaining beyond the extent of the excavation (FWENC 2004). Sample results along Lines 1 and 2 showed concentrations exceeding the SEC (TtEC 2008c). Therefore, additional HHE soil was removed to the extent of the ROD-identified width (10 feet laterally on either side of pipe). Following the removal of the ROD-defined corridor width, Lines 1 and 2 were sampled in accordance with the CSV SAP. Based upon sample results, CSV was identified at the north end of Line 2 as well as the full extent of Line 1 to 20 feet laterally on either side of pipe. The expanded excavation along Lines 1 and 2 resulted in an additional 2,793 bcy of HHE and CSV soil for Line 1 and 1,422 bcy for Line 2. The resulting excavation boundaries and sample locations are shown on Figure 3.2.1-1.

Before continuing the former chemical sewer line removal, additional sampling was performed in accordance with the CSV SAP to determine the extent of contamination west of the excavated material along the chemical sewer alignment. These sample locations are included on Figure 3.2.1-1. Test pits were excavated along the former alignment of Chemical Sewer Lines 6 and 7 at 50-foot intervals to a depth of two feet below the invert of the previously removed pipe. One sample was collected from the floor of the pit and a second sample was collected on the sidewall. Based on the results of the sampling an additional length of 120 feet along the alignment of Chemical Sewer Line 6 east of D Street required removal. No additional remediation was required based on the other sample results (TtEC 2008c). Excavation of soil from former chemical sewer Lines 6 and 7 resulted in an additional 12,707 bcy of remediation volume.

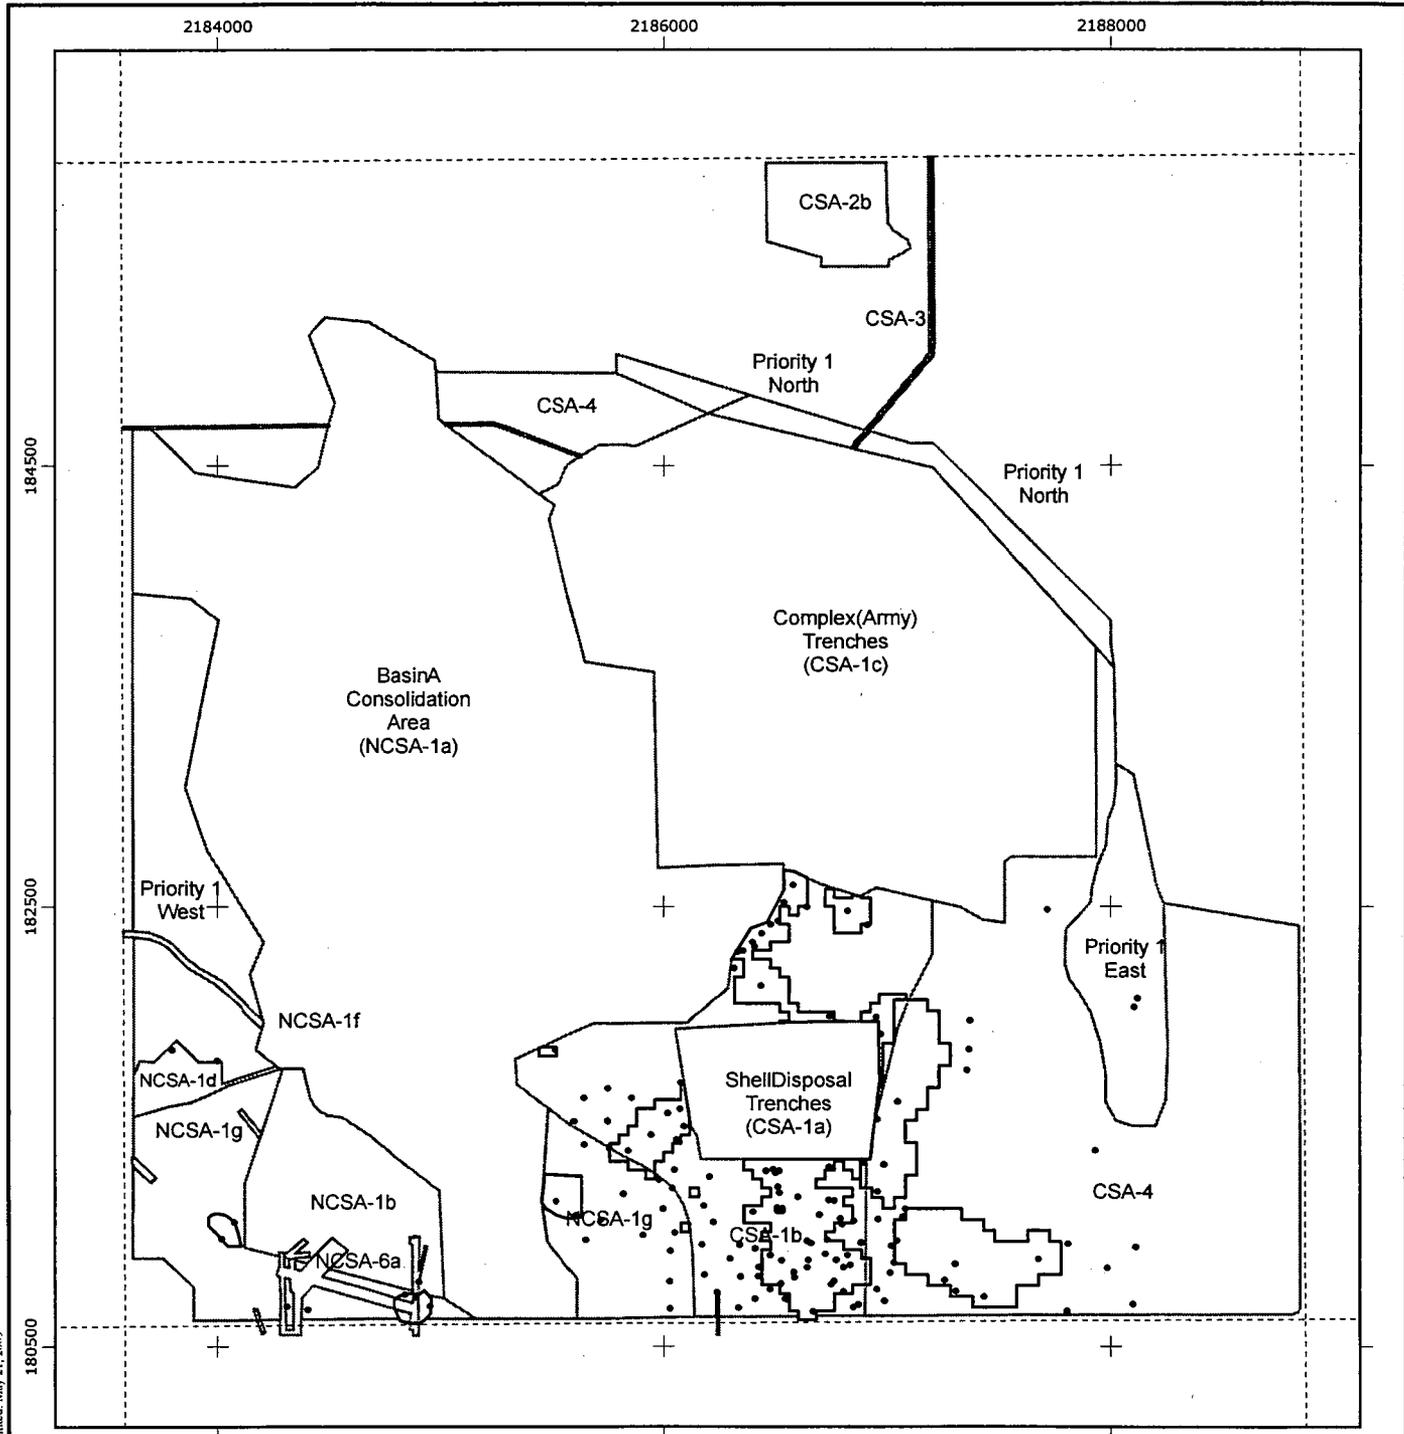
**Figure 3.2.2-1**

**ROCKY MOUNTAIN ARSENAL**  
 Section 36 Balance of Areas  
 Part 1 Confirmatory Soil Sample Locations

- Part 1 Confirmatory Soil Sample Location
- Human Health Exceedance Areas
- Section 36 Balance of Areas Project Boundary

As discussed earlier, the Section 36 BOA project was implemented in two parts, with Part 1 being completed in three phases. All ROD-identified contaminated soil was removed during Part 1 of the project in either Phase 1 or Phase 2. Following completion of Part 1, Phase 2, soil sampling was conducted in accordance with the design ESD to identify and remove remaining contaminated soil and support the basis for eliminating the soil cover. Samples were collected pursuant to the CSV SAP (RVO 2007) and Biota SAP developed specifically for the Section 36 BOA project (FWENC 2003h). Confirmatory sample locations are shown on Figure 3.2.2-1 and the Biota SAP sample locations are shown on Figure 3.2.2-2. The sample results from both events showed that significant areas of HHE and biota risk soils still remained within Section 36 BOA (TtEC 2008c). In addition, extensive chemical staining was identified in the former drum storage area. These stained soils were observed at or below the design excavation surface, indicating that the design sampling may not have located all contamination existing beyond the ROD-identified HHE volume. Pesticide odors were also detected and attributed to this area. While the source of the odors could not be determined, the pesticide nature of the odor suggested a possible relationship to the SDT activities.

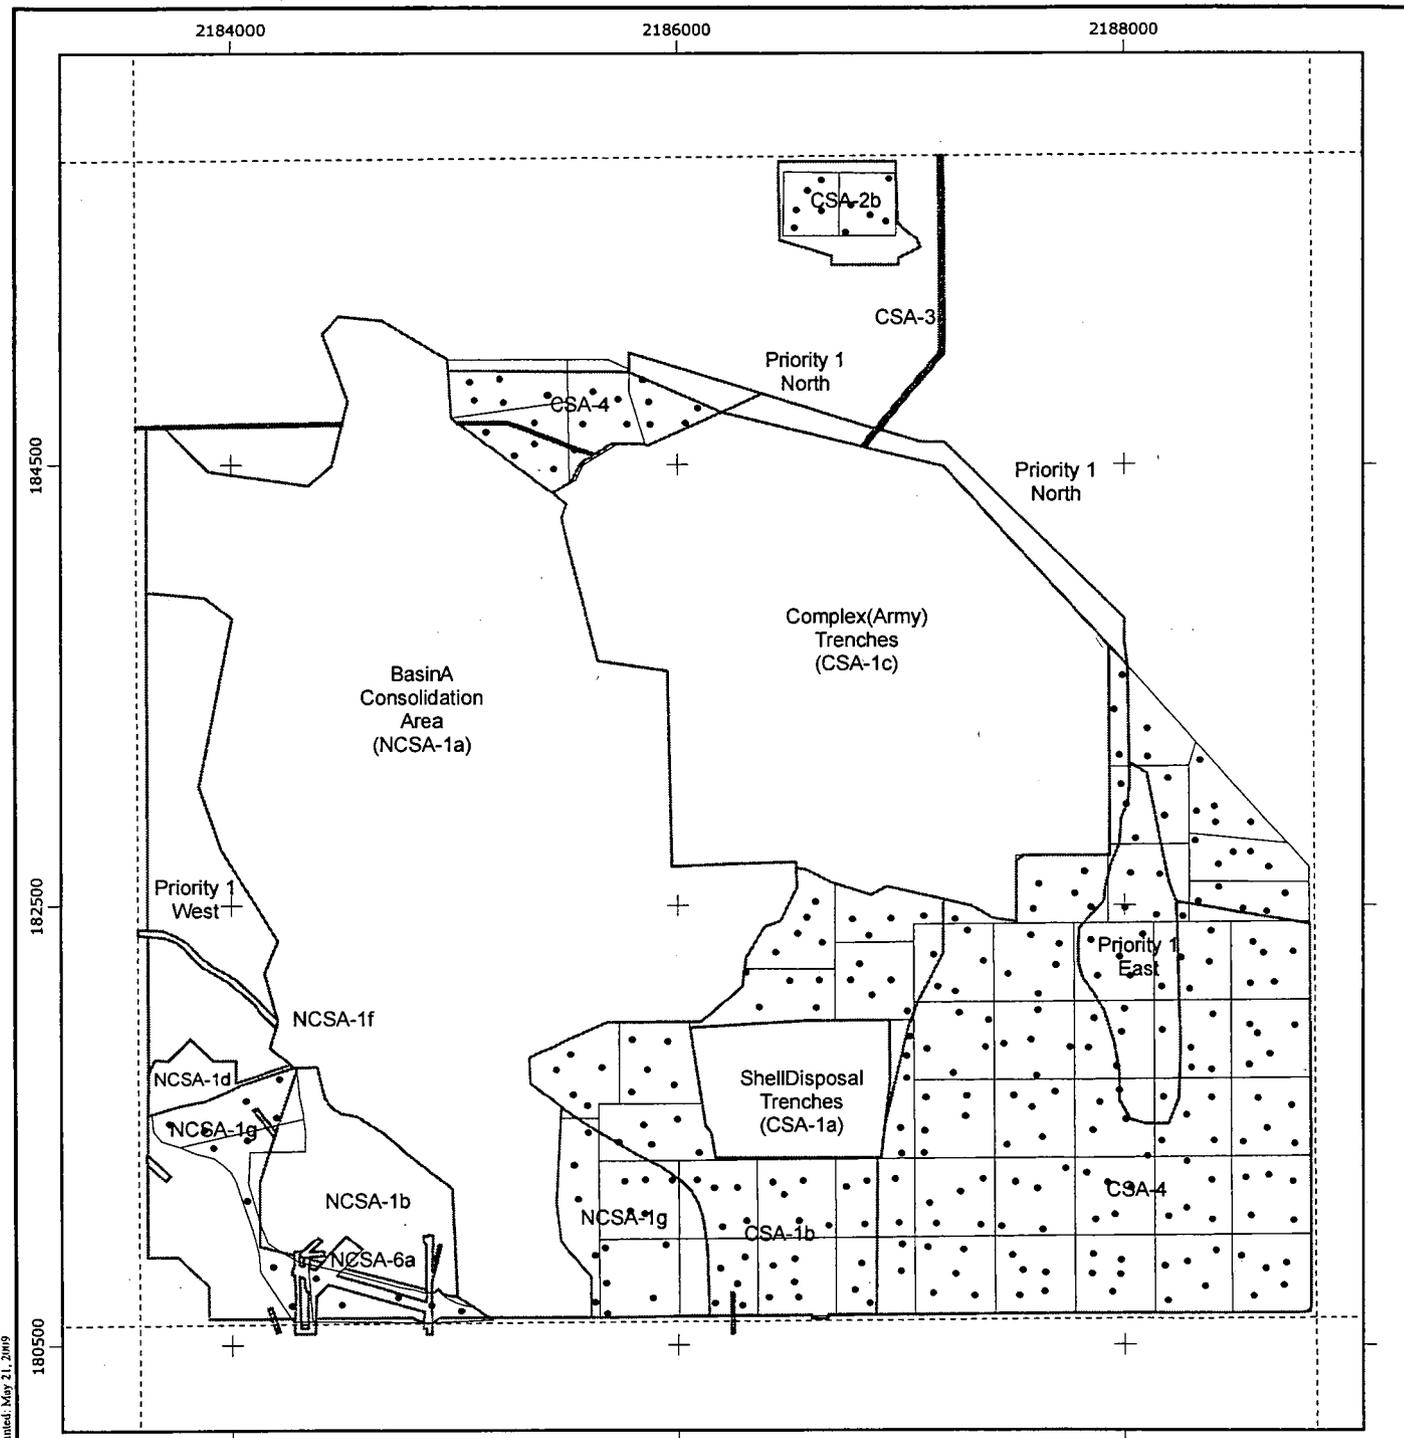
**Figure 3.2.2-2**

**ROCKY MOUNTAIN ARSENAL**  
 Section 36 Balance of Areas  
 Part 1 Composite Soil Sample Locations

- Composite Soil Sample Location
- Composite Soil Sample Parcel
- Section 36 Balance of Areas Project Boundary

Following completion of Part 1, Phase 2, additional soil sampling was conducted throughout the proposed cover deletion area as required by the design ESD. The cover deletion area was divided into 58 approximate 3 acre parcels and 5-point composite samples were collected from the excavation surface within each parcel in accordance with the Biota SAP (FWENC 2003h). Sample locations are shown on Figure 3.2.2-2. The results from this sampling showed that biota risk soils remained in 13 of the parcels (TtEC 2008c). In addition, two of the parcels exceeded human health SEC as discussed in Section 3.1.2. Based on this new information, DCN-BOA-032 was completed to document the results of the sampling and the resulting identified biota risk soils (TtFW 2004b). Excavation of the additional contaminated soil was performed under Part 1, Phase 3 of the project. One parcel, B-56, was not excavated. Instead, this area was incorporated into the South Plants CPA project leaving 4,771 bcy in place beneath the South Plants CPA RCRA-Equivalent cover.

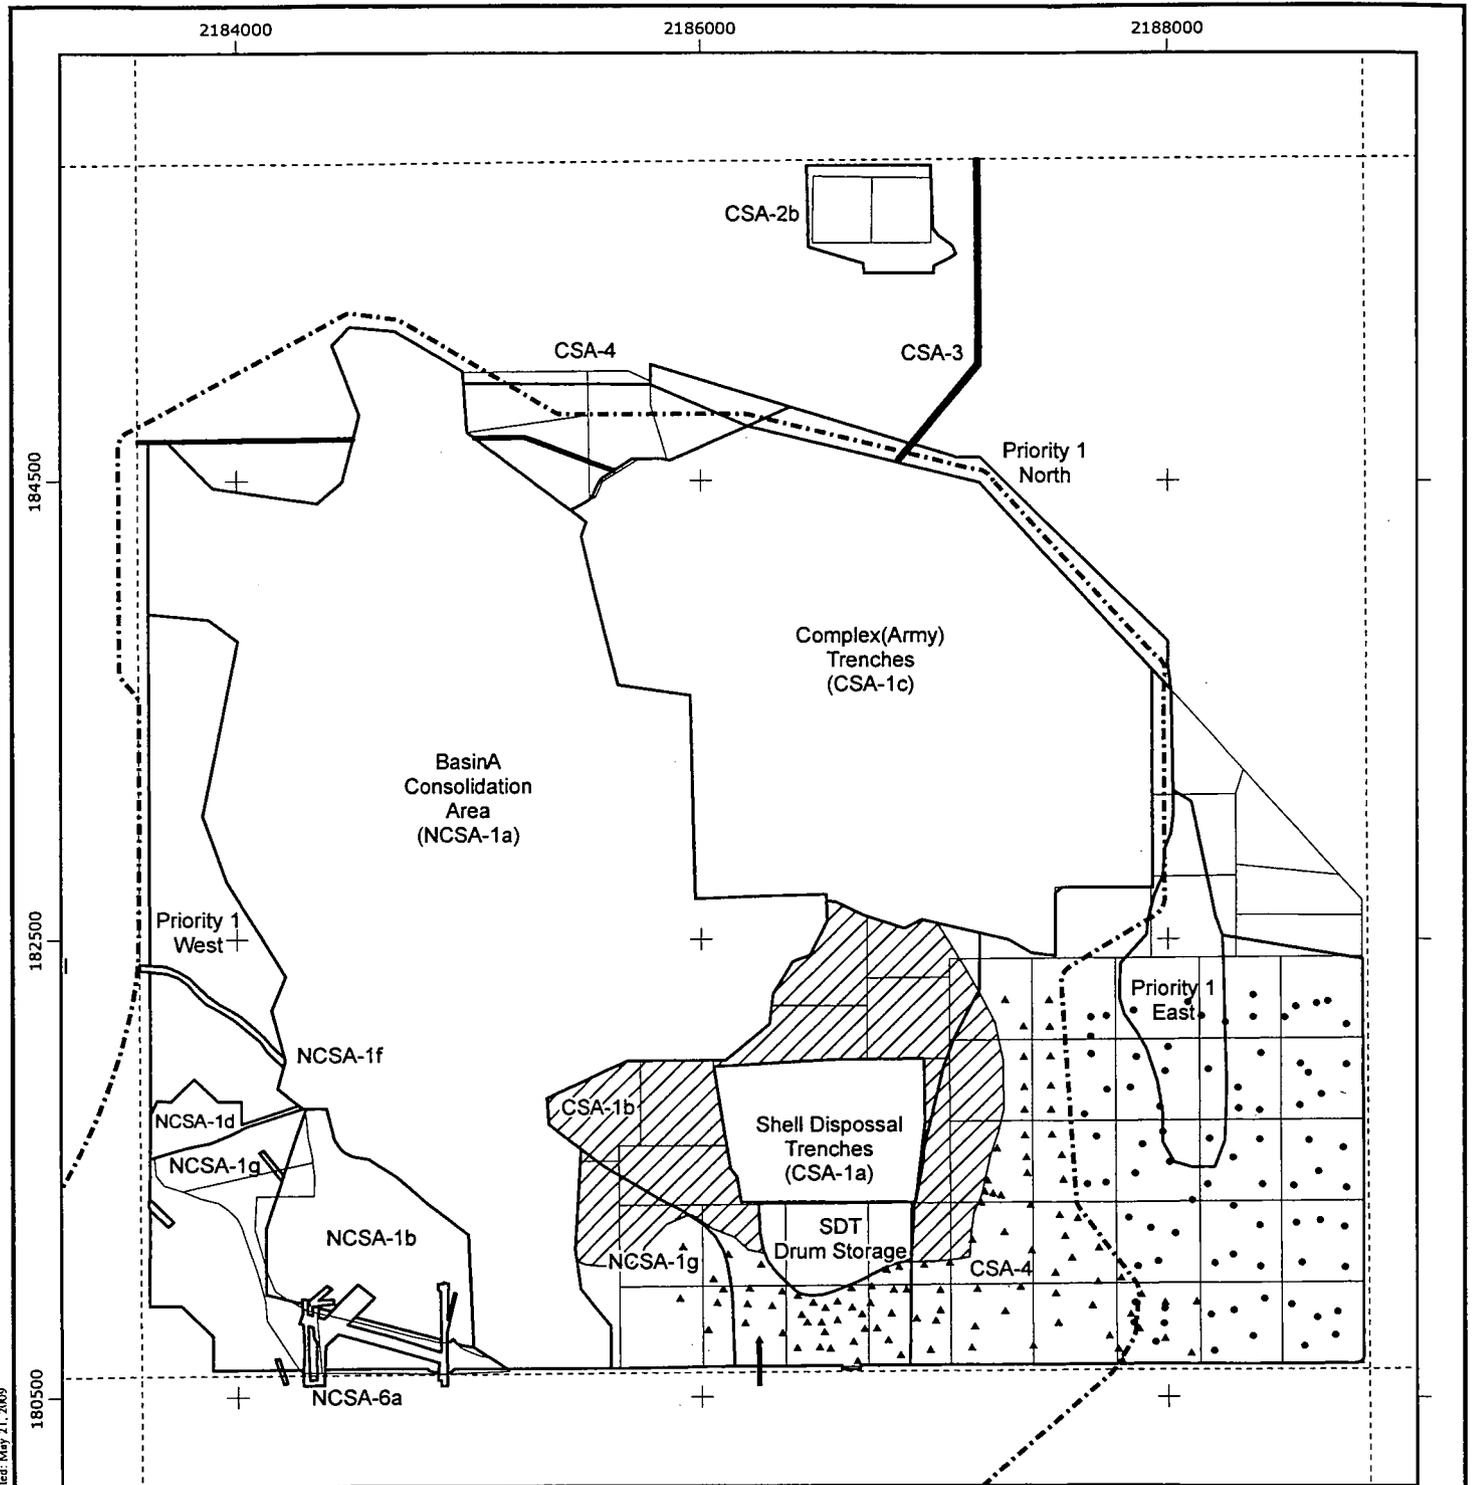
**Figure 3.2.3-1**

## Section 36 Balance of Areas

Additional sampling was conducted following completion of subgrade construction in Part 2 of the project. Discrete samples were collected from the final subgrade surface within the Army-maintained area in accordance with the CSV SAP. Part 2 sample locations are shown on Figure 3.2.3-1. One sample adjacent to the 2-foot cover boundary exceeded the biota risk criteria and approximately 160 bcy of soil were removed. Another 102 bcy were removed from around the lift station near Building 312. Composite samples were collected from the final subgrade surface outside the Army-maintained area in accordance with the Biota SAP. All composite samples were below the biota risk criteria (TtEC 2008a).
